# Manhole Inspection Summary

Manhole # S31UU1005MH

Insp Date: **1/29/07 10:26 AM**

**Location** Address: **201 GOODALE RD**

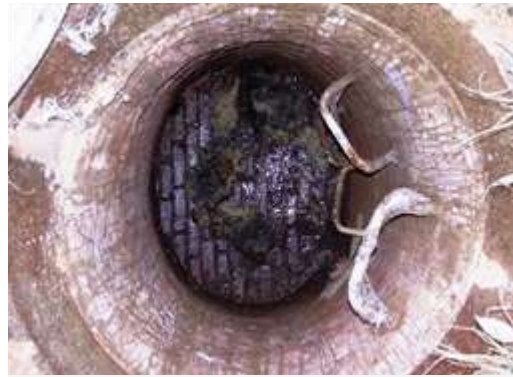
Top View

Corroded steps. Channel debris.

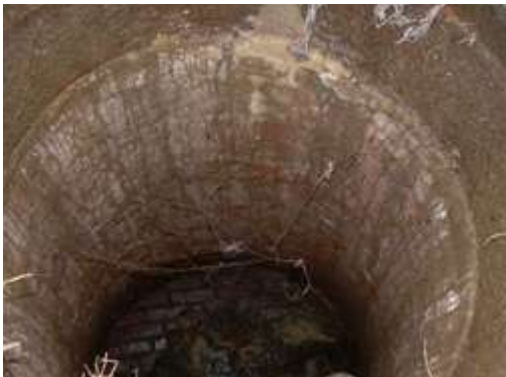
Defect

Frame leaks. Adjustment deterioration. Adjustment and Corbel root intrusion and infiltration.

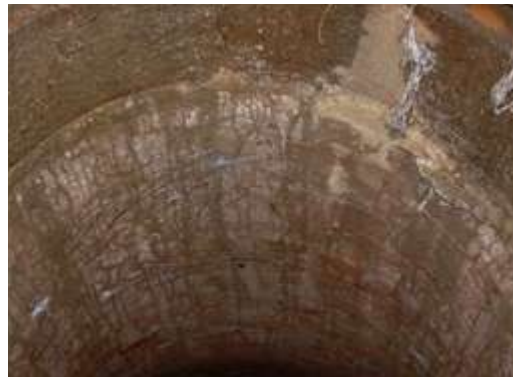
Defect

Frame leaks. Adjustment root intrusion, deterioration, and infiltration.

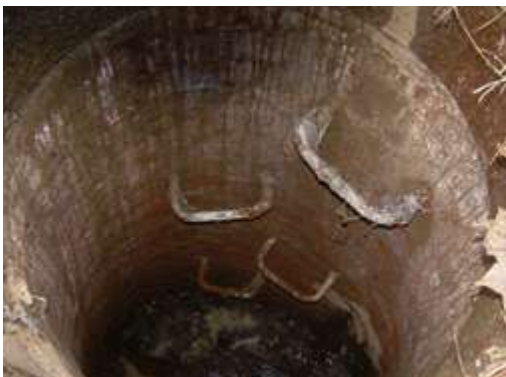
Defect

Adjustment deterioration and infiltration. Corbel infiltration.

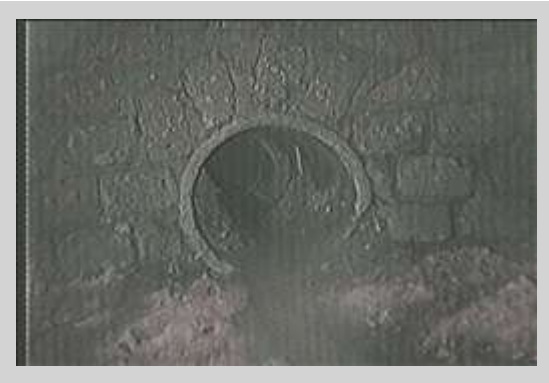
### 8 in. Circular Gravity Sewer Pipe Out @ 12 O'Clock

Barrel deterioration.

Infiltration: **Evidence** Pipe Seal Cond: **Cracked**

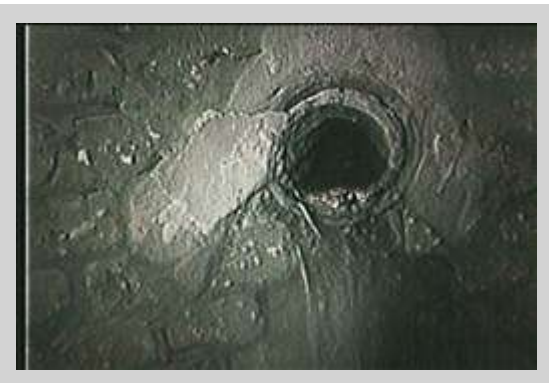
### 4 in. Circular Gravity Sewer Pipe In @ 4 O'Clock

Infiltration: **Evidence** Pipe Seal Cond: **Roots**
